Hydrolox™ Screen Achieves Longer Life and Reduced Maintenance in Highly Abrasive Application

–Yakima, Washington

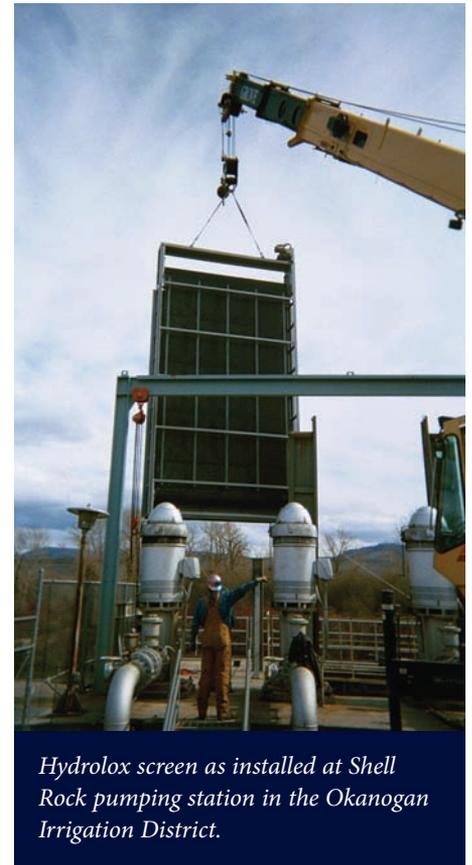
Hydrolox screen as installed at Shell Rock pumping station in the Okanogan Irrigation District.

Working with Hydrolox representatives, the USBR built a frame to accommodate the Hydrolox Series 1800 traveling engineered polymer screen—an answer to their steel screen problems:

- The Hydrolox screen features a sprocket-driven positive drive system, which eliminates uneven wear and mistracking.

- The smooth polymer surface of the Hydrolox screen allows debris to be easily washed away. Also, a spray bar was installed on the front side of the new screen to help eliminate debris carryover.
- The Hydrolox screen mesh extends the life of the screen with non-corrosive, abrasion-resistant screen material.
- Elimination of submerged foot sprockets reduces operations and maintenance.

And because the Hydrolox screen is supported all the way across the mesh, Briggs says, problems associated with sediment build-up and uneven wear are diminished. “It doesn’t sag like the other screens...and as far as holding up in highly corrosive waters—it definitely shows an improvement.”
